Performance results - EPIC Road filtration, SR28 Incline Village, NV.

Jonas Z. Sipaila, CEM

In October of 2016 Nevada Department of Transportation (NDOT) engineers in corroboration with CH2 Hill and Evaporative Control Systems (ECS) designers, contracted with Granite Construction to install the Environmental Passive Integrated Conveyance (EPIC) road filter system for storm-water management and treatment on a 1500' parking lot access road serving the new 3 mile multi use access pathway for Lake Tahoe.

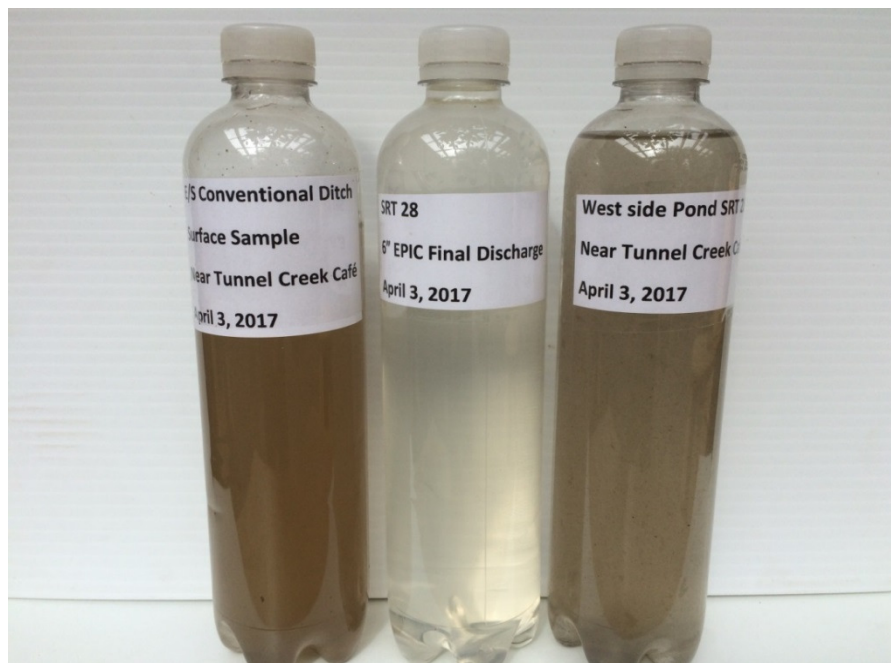
The following picture shows the comparative water quality of the small basins above the EPIC system (left bottle), the large basin discharge water (right bottle), and The EPIC system discharge in the middle.

Fig 1. Comparative sample results from EPIC (center) to current BMPs.

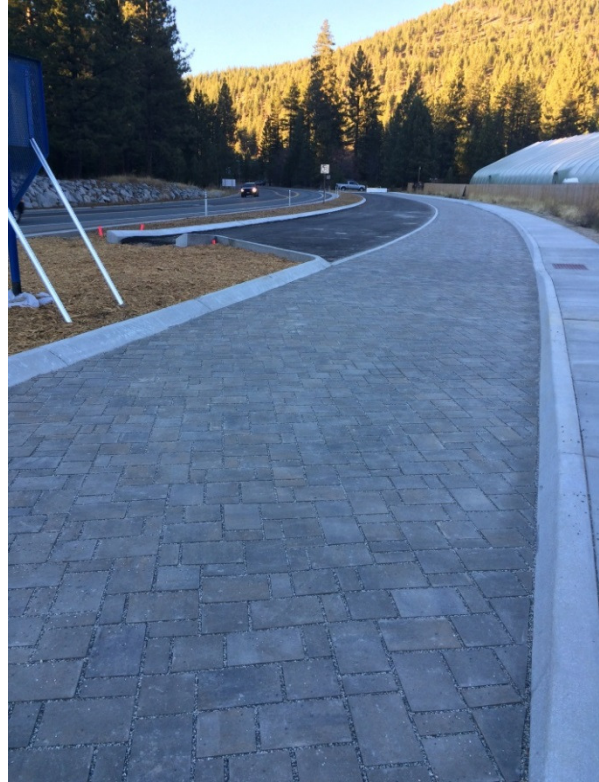
Fig 5. Finished paver surface

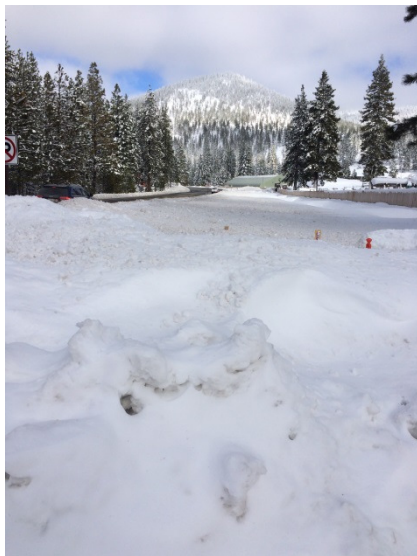
Fig 6. Snow dump buries project

The winter of 2016-2017 was a record snow year for the region. Five foot deep snow accumulated on the yet to be finished project where road snow was directly dumped on the profile from the adjoining all year highway. In April the start of snow-melt runoff exposed the darker and darker snow deposits along with residues left on

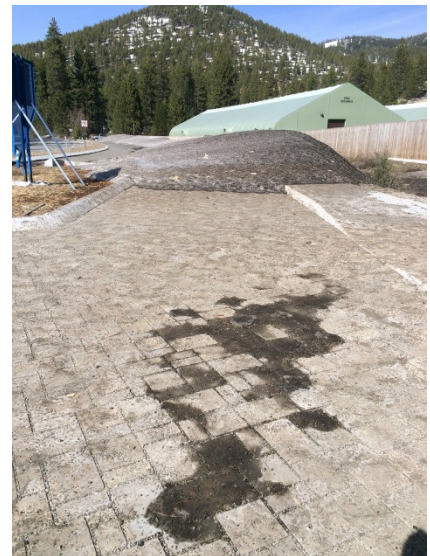
Fig 7. Residues filtered on surface

top of the pavers. This provided the opportunity to study the effectiveness of the system.

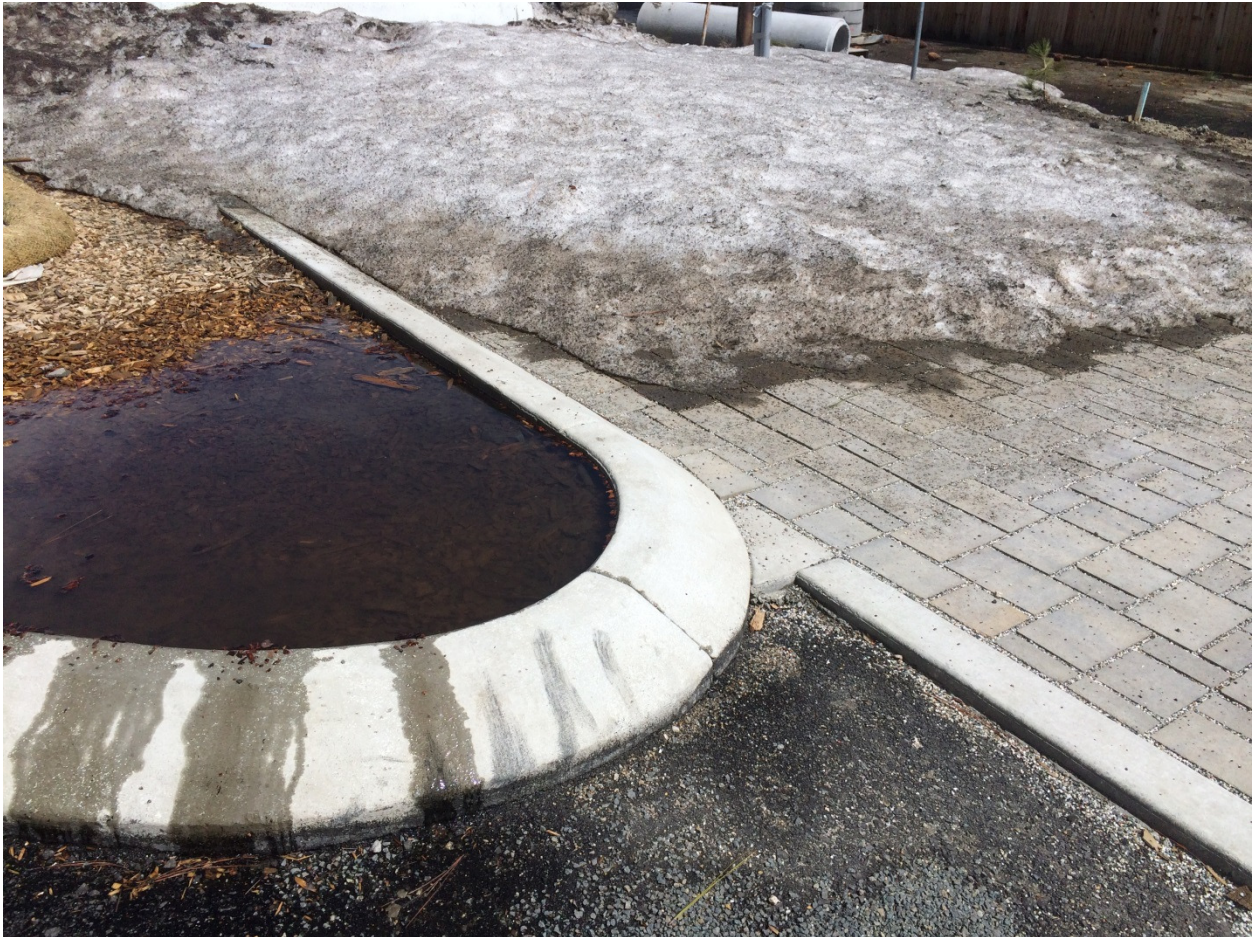
As shown in the following picture, snow melt runoff receded directly into the paver profile with a very short travel distance on the paver surface. Compare this to the runoff situation on the

left side where runoff through “engineered soils” (not over an EPIC drainage profile) simply flowed downhill and overflowed the curbing. The hoped for ground infiltration never occurred. Surface infiltration whether or not capped with porous mulch has a very poor infiltration rate especially on any soil with a clay content and slope.

Fig 8. No soil absorption and overflow left side – vs. quick absorption in Paver area right side

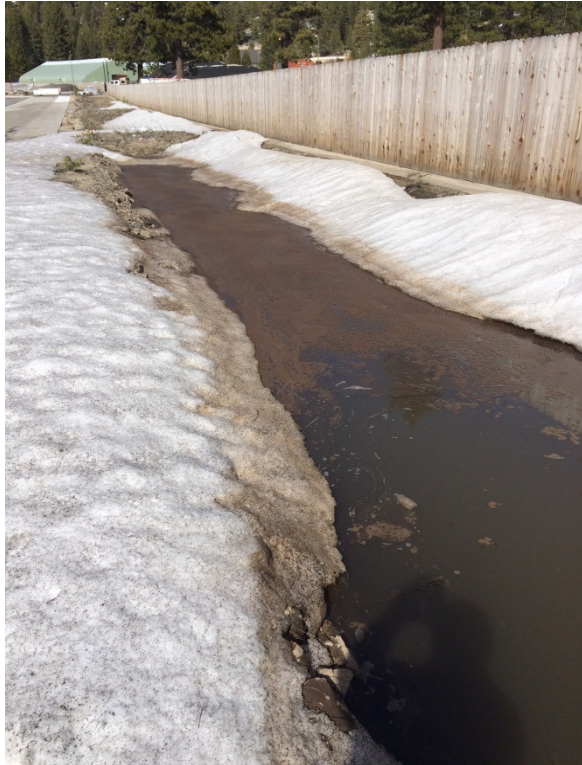
Such a series of basins were adjacent to the EPIC project in a form of stepped and shallow (under 3’ deep) ponds. The following pictures illustrate their effectiveness. In the first picture we note that the stepped ponds are not keeping up with the snowmelt rate as the ponds are full and ground infiltration is not occurring. It is also notable that low density material is simply stagnating on top of the water. Longer springtime water detention in open basins then simply provide breeding grounds for mosquitoes where depending on temperatures the cycle is

completed in 4 days to four weeks. Ground infiltration is not occurring and evaporation loss may be longer than two weeks. Heavier particles (sand, silt, clay) may have settled at the bottom but in the process the non-compacted floc sealed the porosity of the base soil.

Fig 9. Adjacent Infiltration basin BMP

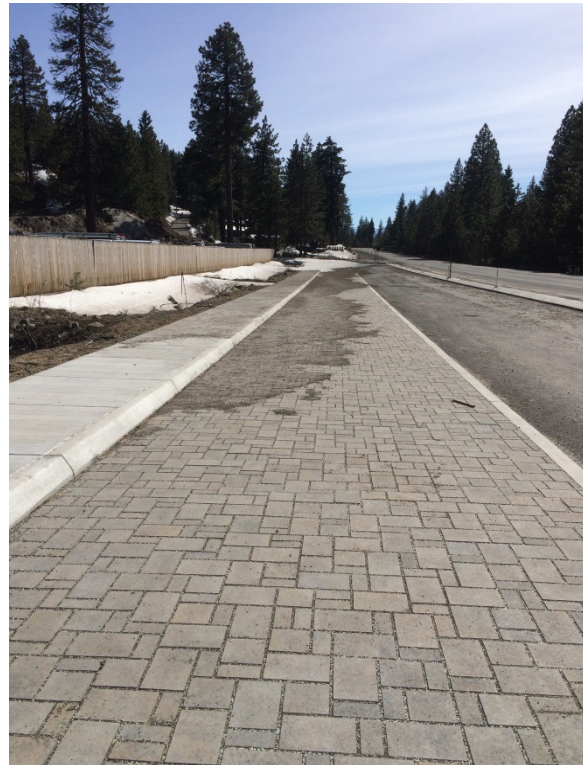
Fig 10. Basin overflows onto EPIC profile

The second picture shows that surge flows due to heavier rain events or fast snow melt are not contained in the basins. In this case the adjoining surface basins overflowed over the sidewalk into the EPIC paver profile where they were absorbed. Of note is that higher flows in surface basins simply re-suspend settled contaminants which subsequently were retained as manageable deposits on top of the paver profile.

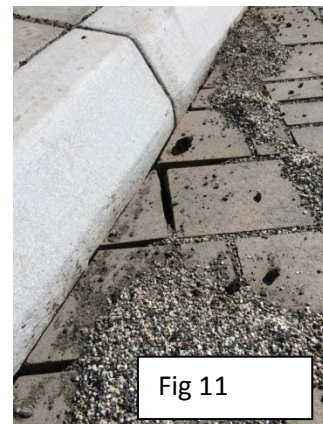
The unplanned adjoining surge flows into the EPIC profile did dislodge locking course fill sand in small areas of the surface paver structure, (see Fig 11) but the integrity of the coarser base foundation was not impacted by the abnormal focused flows. Large water flows were absorbed within a few feet of the focused dumping point demonstrating the effectiveness of handling fast moving water in surge situations. Sweeping the dislodged sand into the open paver crevices repairs the problem.

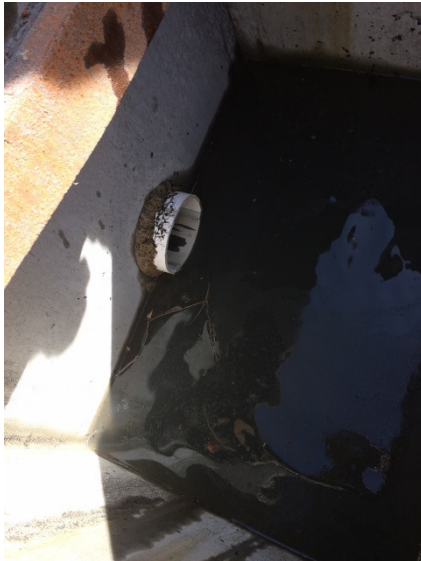
While technically the EPIC profile constructs a below ground detention basin 3” deep, ground infiltration into the base soil is probably not any better than surface ponds. During the sampling inspection the clear water flow rate from the 6” collection pipe was about 0.3 cubic feet per second (cfs) indicating that ground absorption was not occurring at a significant or measurable rate and/or the geo-fabric permeability was compromised.

Fig 12. EPIC discharge point

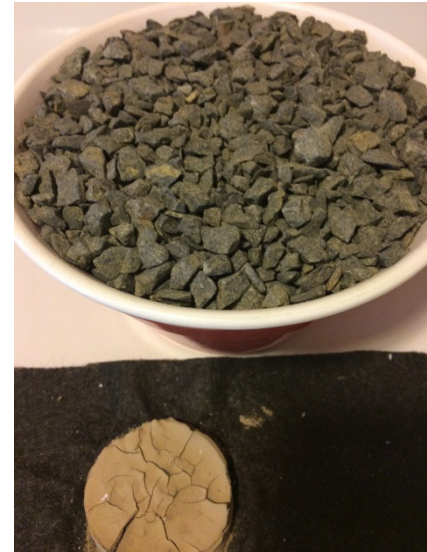
Subsequent testing confirmed what is common with geo-fabrics. Simple rinsing of gravel (or any aggregate) dislodges adhered clay particles from the gravel and deposits them on top of the geo-fabric. In this experiment four pounds of the subject gravel was rinsed and collected on top of the geo-textile

Fig 13. Clay filtrate on geo-fabric

producing a ¼” thick deposit of impermeable clay particles. While geo-fabrics can have a structural benefit to separate aggregates or insulate aggregates from native soils, the reliance of geo-fabrics to pass water into ground water formations is highly dubious and probably does not occur with any significance long term. As EPIC performance reliance is focused on surface filtration, the presence or absence of geo-fabrics in the EPIC system, or substituting the geo-fabric floor with a totally impermeable EPDM liner is an academic decision dependent on the intended destination of the filtered and treated water volume.

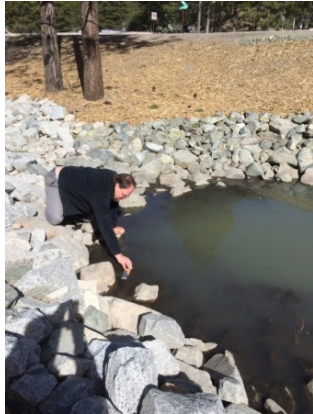
Without disturbing the bottom sediment of the two surface basin systems, surface water was sampled and compared with the discharge point of the EPIC Filter at the terminal point of the 6" final discharge.

Fig 14. Surface BMP sampling

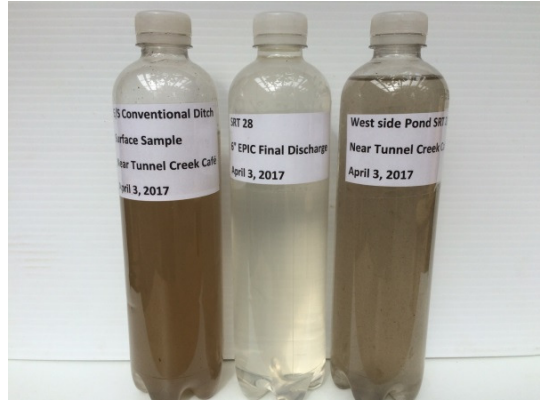
Fig 15. BMP vs. EPIC samples (center)

Dramatic water quality differences were obvious, dramatically reducing turbidity levels of storm water prior to entering Lake Tahoe or other bodies of water. The driving force for EPIC road filters however, is that it vastly improves safety conditions in the public driving corridors.
